**Flood Control Project Maintenance
Levee Inspections**

Fall 2014 Levee Maintenance Deficiency Summary Report

Sutter Maintenance Yard Maintenance Area 0005

Levee Inspection Report By Mile - Fall 2014

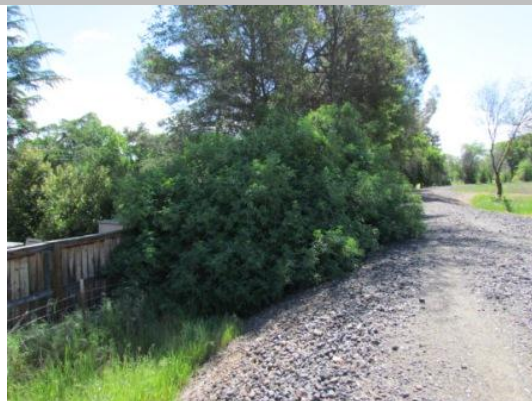
Photo 1 of 1 : FA_2014_MA0005_196_903_20141013_00013.jpg

LM Start	0.58	Rating **	M	Issue No.	903
LM End	0.58	Issue Type +	Ma	Location *	LS
Category	Earthen Levee			GPS Latitude/Longitude	
				Start	End
Item	Vegetation			39.690745 °	39.690745 °
				-121.777342 °	-121.777342 °
DWR ID	DWR_MA0005_01_s_2012_903				
Action/Comments					
Elderberries are blocking visibility and flood fight capability.

View of the large elderberries along the L/S toe.

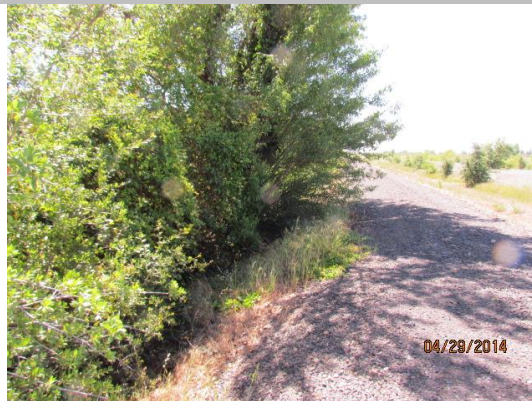
Photo 1 of 1 : FA_2014_MA0005_196_32_20141013_00010.jpg

LM Start	0.78	Rating **	M	Issue No.	32
LM End	0.78	Issue Type +	Ma	Location *	LS
Category	Earthen Levee			GPS Latitude/Longitude	
				Start	End
Item	Trim / Thin Trees			39.687917 °	39.687917 °
				-121.777393 °	-121.777393 °
DWR ID	DWR_MA0005_01_s_2014_32				
Action/Comments					
Thin trees to allow visibility of the ground and room to flood fight.

Trim the trees along the landside slope.

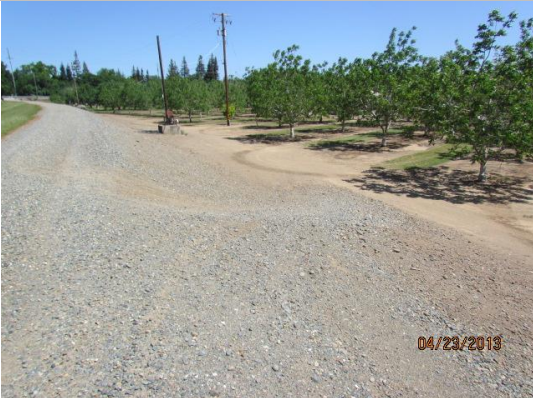
Photo 1 of 1 : FA_2014_MA0005_196_16_20141013_000007.jpg

View of the sprinkler pipe and equipment along the landside toe.

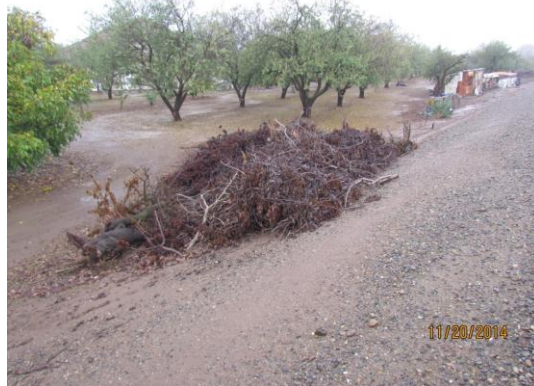
Photo 1 of 1 : FA_2014_MA0005_196_34_20141126_00017.jpg

View of the prunings along the landside toe.

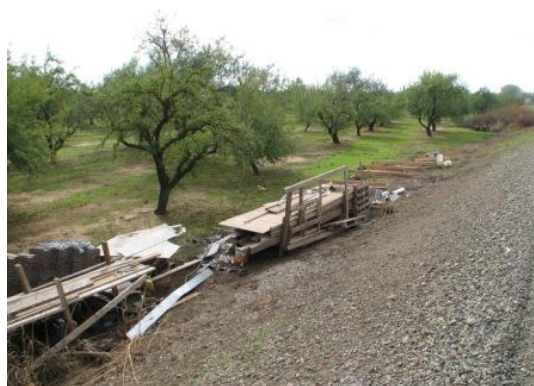
Photo 1 of 1 : FA_2014_MA0005_196_1_20141013_00001.jpg

View of the removed garbage but construction supply on pallets.

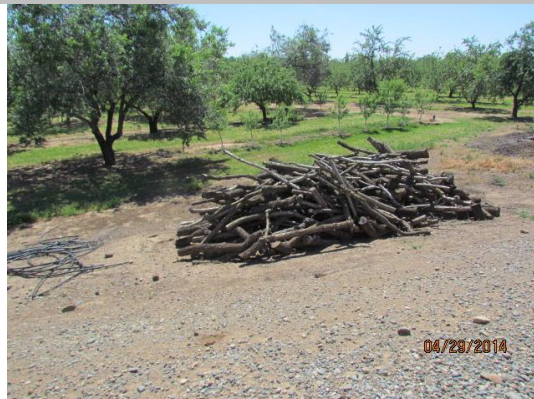
Photo 1 of 1 : FA_2014_MA0005_196_33_20141013_00011.jpg

View of the firewood along the landside toe.

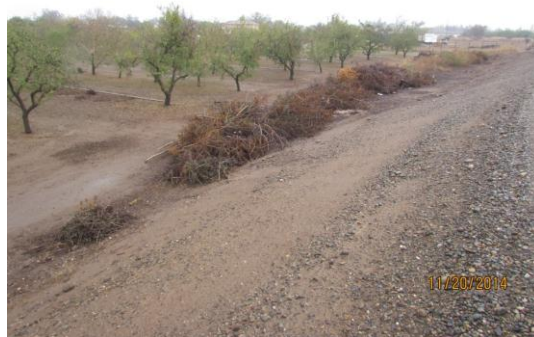
Photo 1 of 1 : FA_2014_MA0005_196_35_20141126_00018.jpg

View of the prunings along the landside toe.

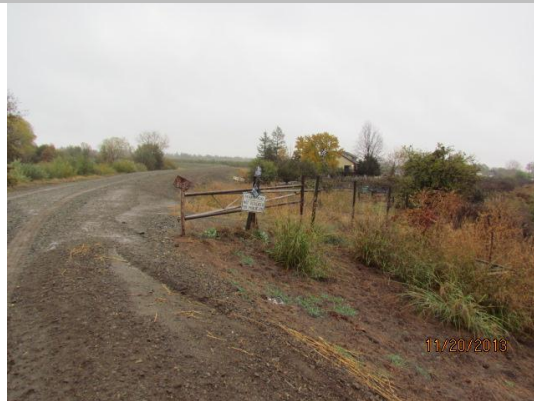
Photo 1 of 1 : FA_2014_MA0005_196_10_20141013_00006.jpg

View of the gate with no permit.

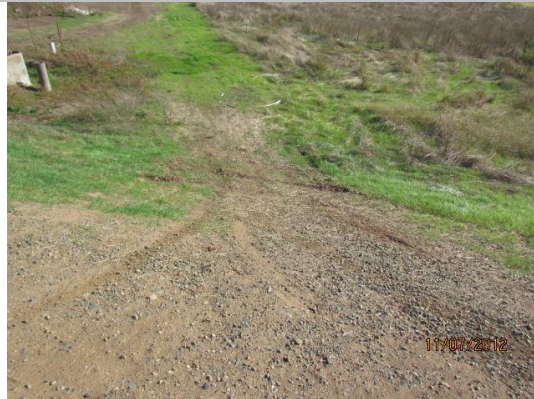
Photo 1 of 1 : FA_2014_MA0005_196_9_20141013_00005.jpg

View of the vehicle erosion along the landside slope.

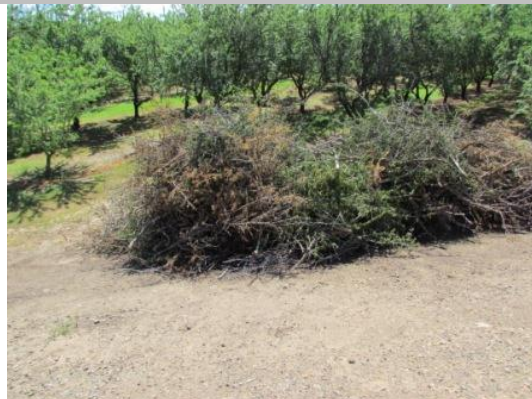
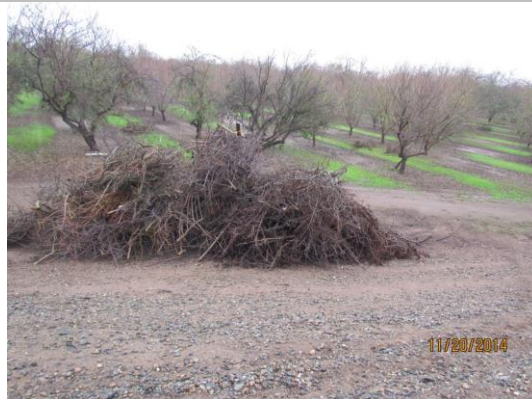
Photo 1 of 2 : FA_2014_MA0005_196_2_20141013_00002.jpg

LM Start	3.13	Rating **	M	Issue No.	2
LM End	3.13	Issue Type +	En	Location *	LS
Category	Earthen Levee			GPS Latitude/Longitude	
				Start	End
Item	Encroachments			39.656735 °	39.656735 °
				-121.787163 °	-121.787163 °
DWR ID	DWR_MA0005_01_f_2014_2				
Action/Comments					
Prunings

View of the large prunings pile along the L/S toe.

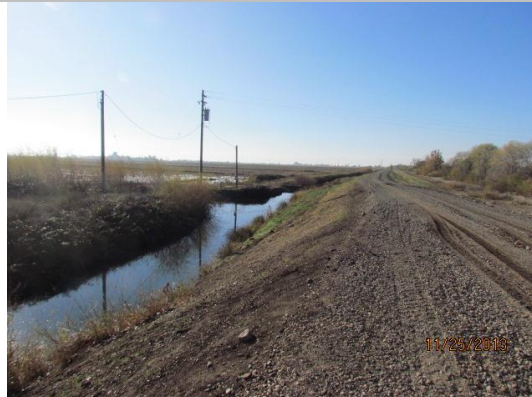
Photo 1 of 1 : FA_2014_MA0005_196_55_20141013_00012.jpg

LM Start	5.79	Rating **	M	Issue No.	55
LM End	6.34	Issue Type +	En	Location *	LS
Category	Earthen Levee			GPS Latitude/Longitude	
				Start	End
Item	Encroachments			39.622766 °	39.615666 °
				-121.773159 °	-121.777353 °
DWR ID	DWR_MA0005_01_f_2013_55				
Action/Comments					
Ditch

View of the irrigation ditch along the landside toe.

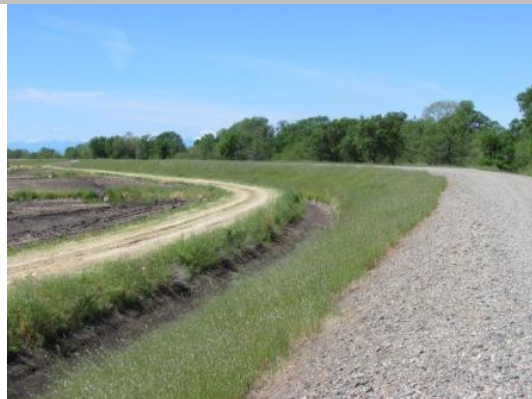
Photo 1 of 1 : FA_2014_MA0005_196_5_20141013_00003.jpg

LM Start	9.66	Rating **	M	Issue No.	5
LM End	10.48	Issue Type +	En	Location *	N/A
Category	Earthen Levee			GPS Latitude/Longitude	
				Start	End
Item	Encroachments			39.574837 °	39.567892 °
				-121.807913 °	-121.819283 °
DWR ID	DWR_MA0005_01_s_2012_5				
Action/Comments					
Ditch

View of the agricultural ditch along the L/S toe.

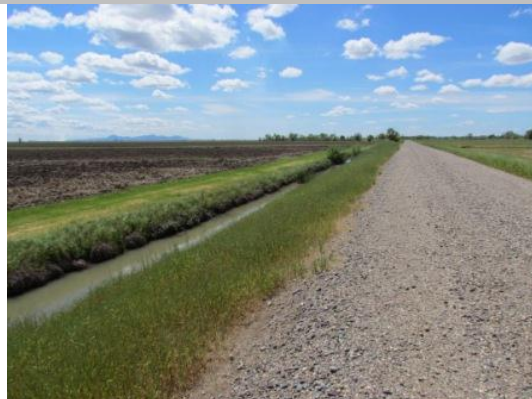
Photo 1 of 1 : FA_2014_MA0005_196_6_20141013_00004.jpg

LM Start	12.00	Rating **	M	Issue No.	6
LM End	13.83	Issue Type +	En	Location *	LS
Category	Earthen Levee			GPS Latitude/Longitude	
				Start	End
Item	Encroachments			39.551235 °	39.531462 °
				-121.837697 °	-121.856165 °
DWR ID	DWR_MA0005_01_s_2012_6				
Action/Comments					
Ditch

View of the AG ditch along the L/S toe.

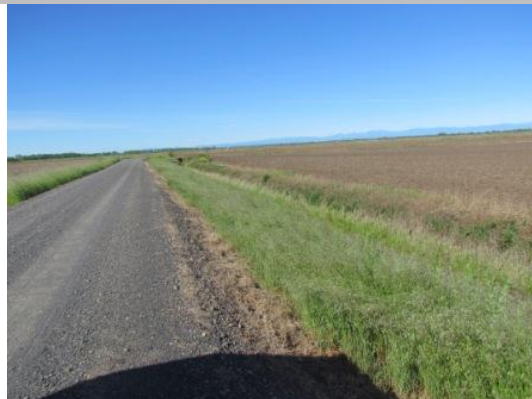
Photo 1 of 1 : FA_2014_MA0005_197_1_20141013_00001.jpg

LM Start	1.23	Rating **	M	Issue No.	1
LM End	1.62	Issue Type +	En	Location *	LS
Category	Earthen Levee			GPS Latitude/Longitude	
				Start	End
Item	Encroachments			39.529933 °	39.534102 °
				-121.861563 °	-121.856947 °
DWR ID	DWR_MA0005_02_s_2012_1				
Action/Comments					
Ditch

View of the AG ditch along the L/S toe.

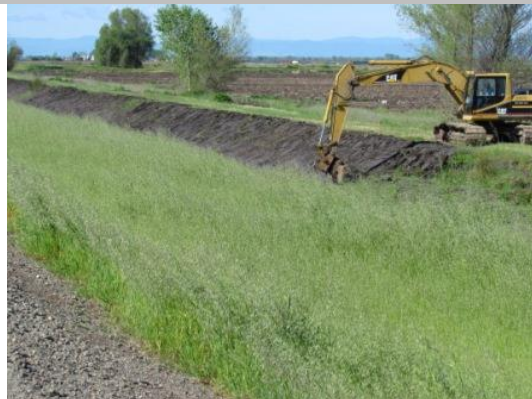
Photo 1 of 1 : FA_2014_MA0005_197_7_20141013_00005.jpg

LM Start	3.15	Rating **	M	Issue No.	7
LM End	4.60	Issue Type +	En	Location *	LS
Category	Earthen Levee			GPS Latitude/Longitude	
				Start	End
Item	Encroachments			39.551780 °	39.567430 °
				-121.840507 °	-121.823065 °
DWR ID	DWR_MA0005_02_s_2012_7				
Action/Comments					
Ditch

View of the AG ditch along the L/S toe.

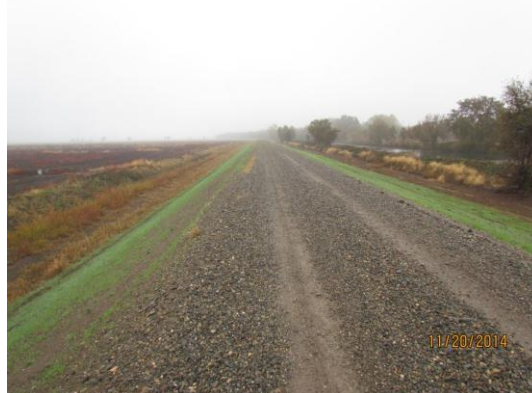
Photo 1 of 1 : FA_2014_MA0005_197_39_20141126_00019.jpg

LM Start	5.07	Rating **	A	Issue No.	39
LM End	5.07	Issue Type +	Ma	Location *	LS
Category	Earthen Levee			GPS Latitude/Longitude	
				Start	End
Item	Vegetation			39.572245 °	39.572245 °
				-121.816902 °	-121.816902 °
DWR ID	DWR_MA0005_02_f_2014_39				
Action/Comments					
Control annual grass and weeds on the levee slopes and easements.

View of the controlled vegetation on both slopes.

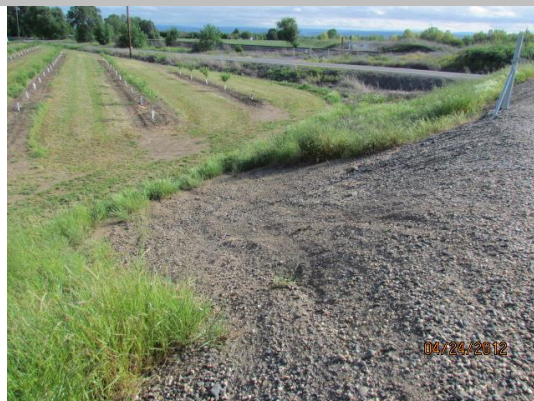
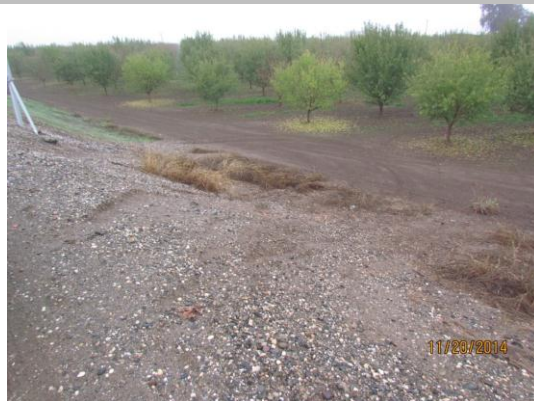
Photo 1 of 2 : FA_2014_MA0005_197_13_20141013_00007.jpg

LM Start	8.10	Rating **	M	Issue No.	13
LM End	8.10	Issue Type +	Ma	Location *	LS
Category	Earthen Levee			GPS Latitude/Longitude	
				Start	End
Item	Slope Stability			39.607710 °	39.607710 °
				-121.785868 °	-121.785868 °
DWR ID	DWR_MA0005_02_s_2012_13				
Action/Comments					
Repair the levee slope damaged by vehicle traffic and prevent access where possible.

View of the vehicle erosion along the slope.

View of the vehicle erosion along the landside slope.

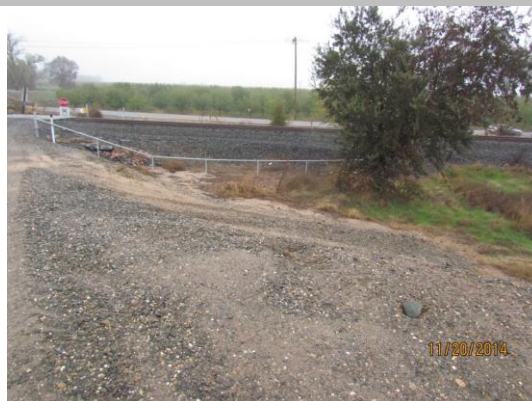
Photo 1 of 1 : FA_2014_MA0005_197_40_20141126_00021.jpg

LM Start	8.17	Rating **	M	Issue No.	40
LM End	8.17	Issue Type +	Ma	Location *	LS
Category	Earthen Levee			GPS Latitude/Longitude	
				Start	End
Item	Slope Stability			39.608563 °	39.608563 °
				-121.785058 °	-121.785058 °
DWR ID	DWR_MA0005_02_f_2014_40				
Action/Comments					
Repair the levee slope damaged by vehicle traffic and prevent access where possible.

View of the vehicle erosion along the landside slope.

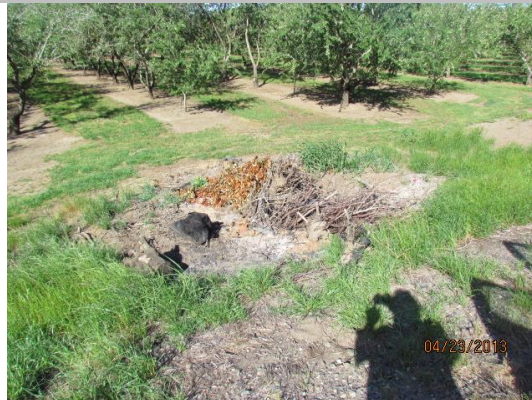
Photo 1 of 1 : FA_2014_MA0005_197_3_20141013_00002.jpg

LM Start	10.54	Rating **	M	Issue No.	3
LM End	10.54	Issue Type +	Ma	Location *	LS
Category	Earthen Levee			GPS Latitude/Longitude	
				Start	End
Item	Encroachments			39.639018 °	39.639018 °
				-121.781458 °	-121.781458 °
DWR ID	DWR_MA0005_02_s_2012_3				
Action/Comments					
Prunings

View of the prunings along the landside toe.

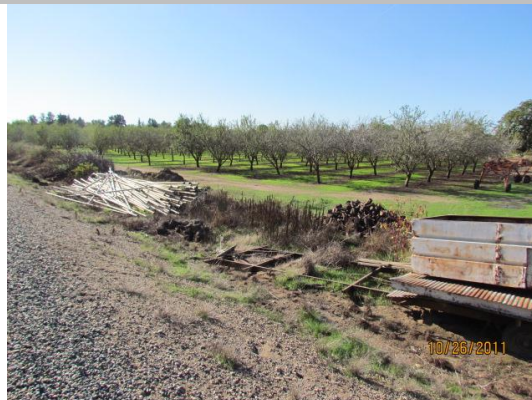
Photo 1 of 1 : FA_2014_MA0005_197_14_20141013_00008.jpg

LM Start	10.61	Rating **	M	Issue No.	14
LM End	10.61	Issue Type +	En	Location *	LS
Category	Earthen Levee			GPS Latitude/Longitude	
				Start	End
Item	Encroachments			39.639967 °	39.639967 °
				-121.782152 °	-121.782152 °
DWR ID	DWR_MA0005_02_s_2012_14				
Action/Comments					
Equipment

View of the equipment along the L/S toe.

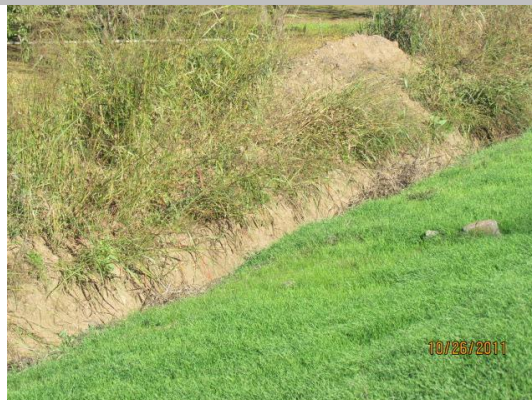
Photo 1 of 1 : FA_2014_MA0005_197_6_20141013_00004.jpg

LM Start	11.74	Rating **	M	Issue No.	6
LM End	11.95	Issue Type +	En	Location *	LS
Category	Earthen Levee			GPS Latitude/Longitude	
				Start	End
Item	Encroachments			39.654268 °	39.657142 °
				-121.789525 °	-121.788690 °
DWR ID	DWR_MA0005_02_s_2012_6				
Action/Comments					
Ditch

View of the ditch along the L/S toe.

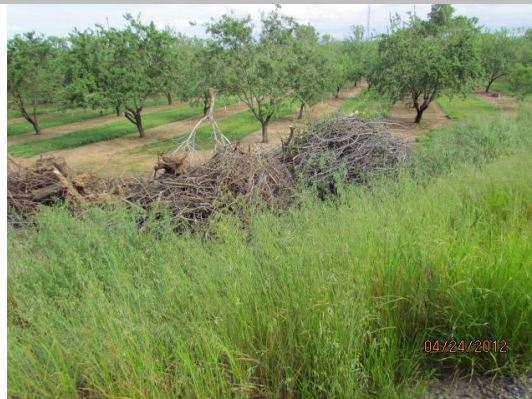
Photo 1 of 1 : FA_2014_MA0005_197_19_20141013_00013.jpg

LM Start	13.03	Rating **	M	Issue No.	19
LM End	13.03	Issue Type +	En	Location *	LS
Category	Earthen Levee			GPS Latitude/Longitude	
				Start	End
Item	Encroachments			39.671239 °	39.671239 °
				-121.782486 °	-121.782486 °
DWR ID	DWR_MA0005_02_s _ 2012_19				
Action/Comments					
Prunings

View of the brush pile at the toe of the levee.

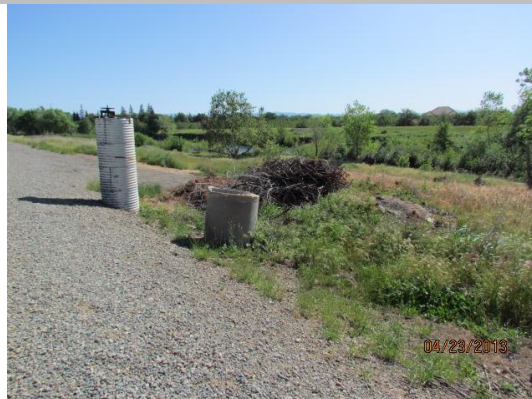
Photo 1 of 1 : FA_2014_MA0005_197_22_20141013_00015.jpg

LM Start	13.35	Rating **	M	Issue No.	22
LM End	13.35	Issue Type +	En	Location *	WS
Category	Earthen Levee			GPS Latitude/Longitude	
				Start	End
Item	Encroachments			39.675311 °	39.675311 °
				-121.780371 °	-121.780371 °
DWR ID	DWR_MA0005_02_s _ 2013_22				
Action/Comments					
Prunings

View of the prunings along the waterside toe.

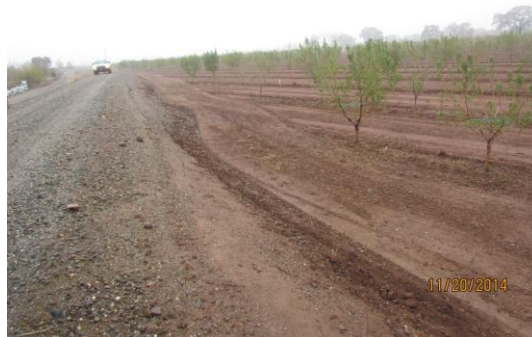
Photo 1 of 1 : FA_2014_MA0005_197_43_20141126_00027.jpg

View of where the landowner is disked into the landside slope.

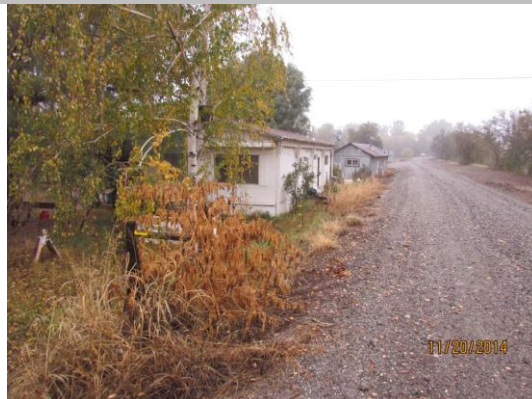
Photo 1 of 1 : FA_2014_MA0005_197_25_20141126_00028.jpg

View of the buildings at the landside toe.

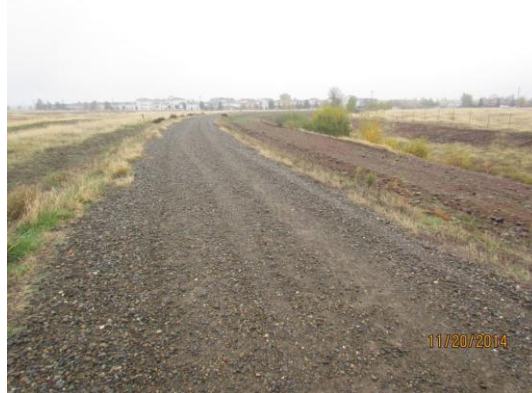
Photo 1 of 1 : FA_2014_MA0005_198_1_20141126_00001.jpg

View of controlled vegetation on both slopes.
